Pavement Evaluation Report

Jerome Stake Center
26 North 100 East, Jerome, Idaho
Property No. 5202701

Re: Pavement Evaluation Report
Jerome Stake Center – Property No. 5202701
26 North 100 East
Jerome, Idaho
Terracon Project No. 62225035

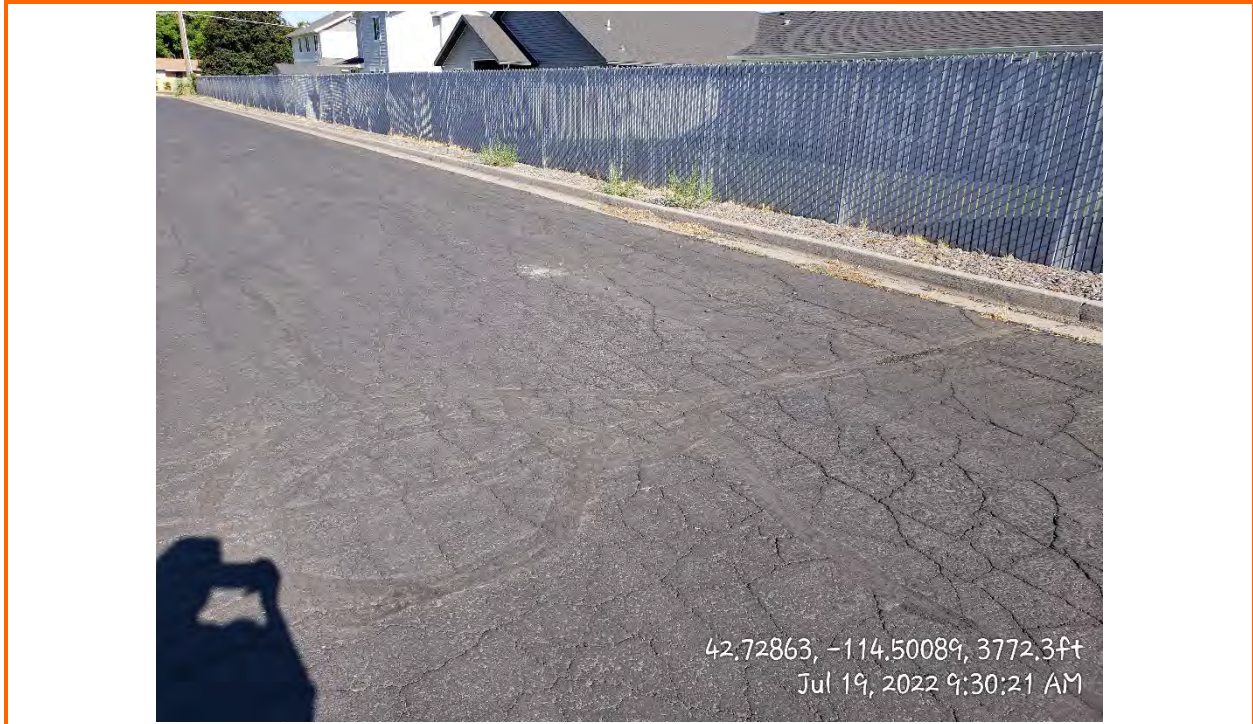
North Lot – Transverse, Longitudinal, Block, and Alligator Cracking, Some with Sealant

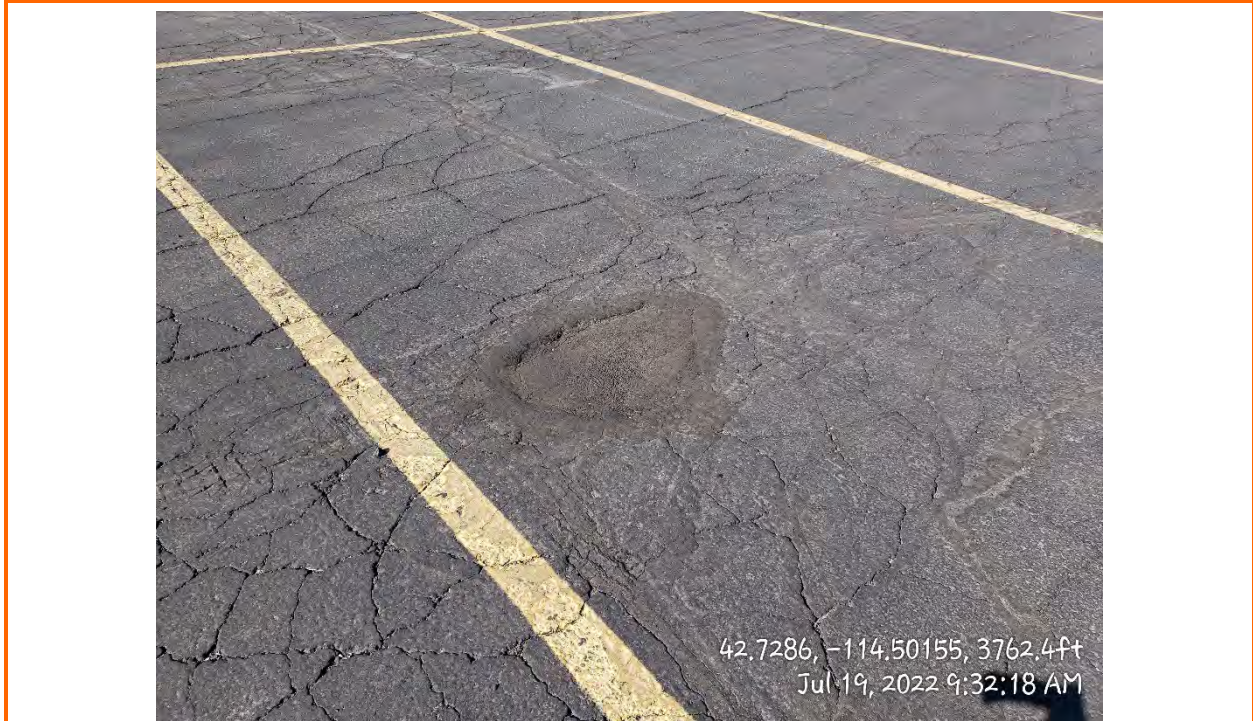
North Lot – Block and Alligator Cracking with Pothole

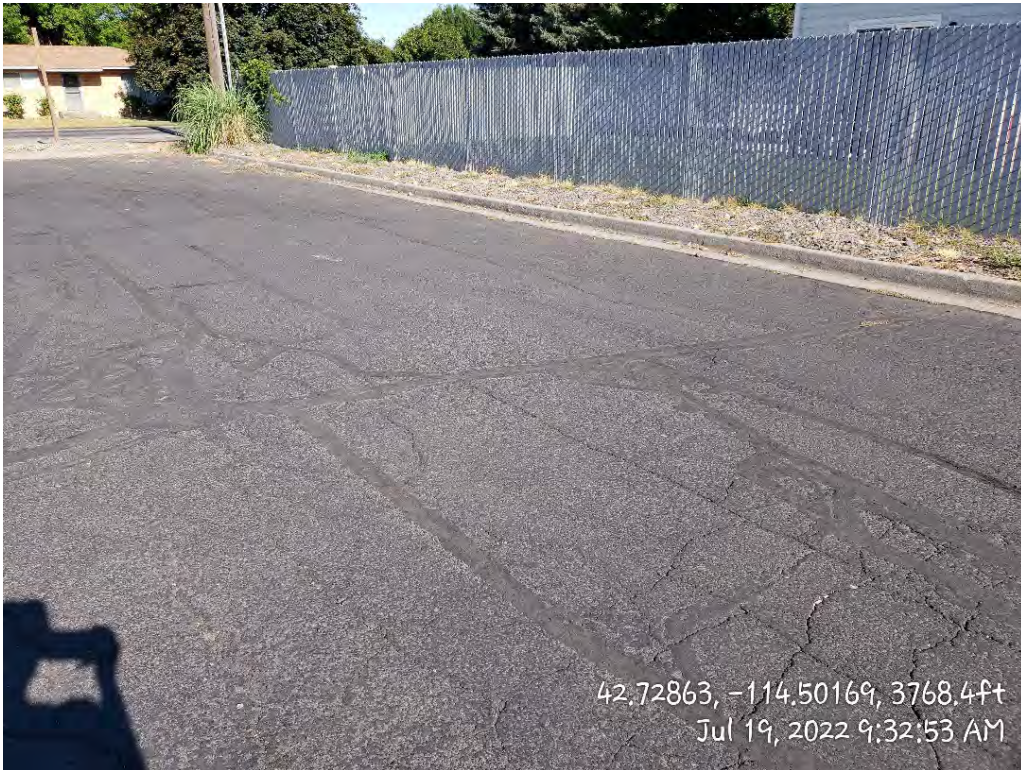
North Lot – Transverse, Longitudinal, and Block Cracking, Some with Sealant

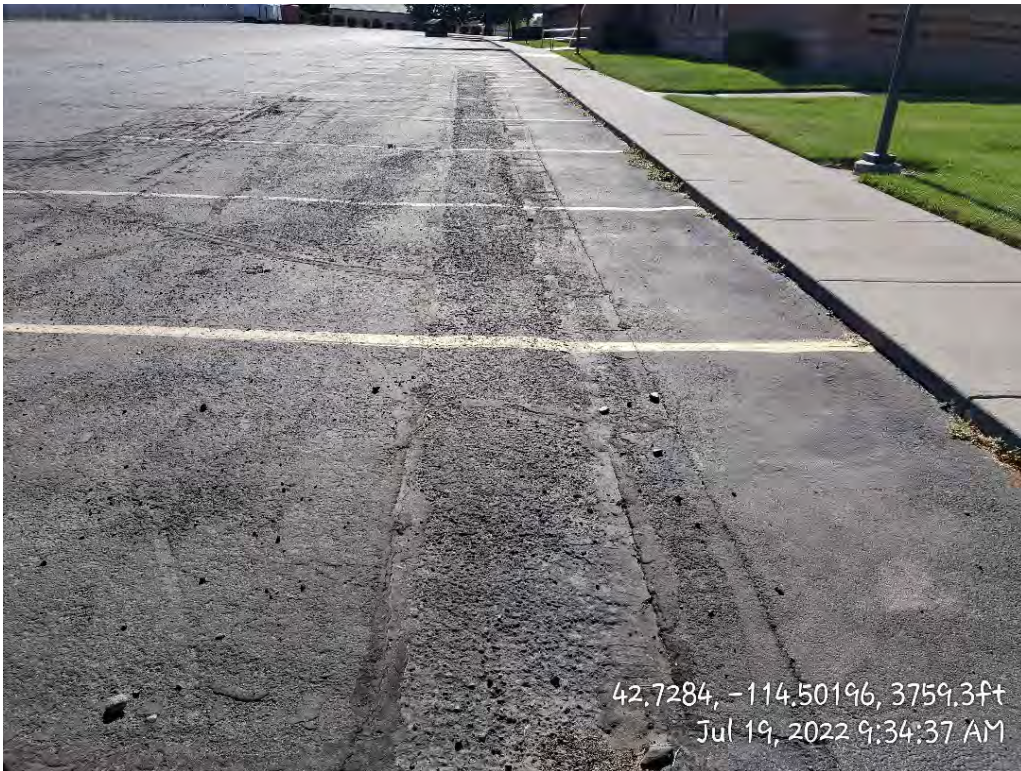
North Lot –Patch with Raveling

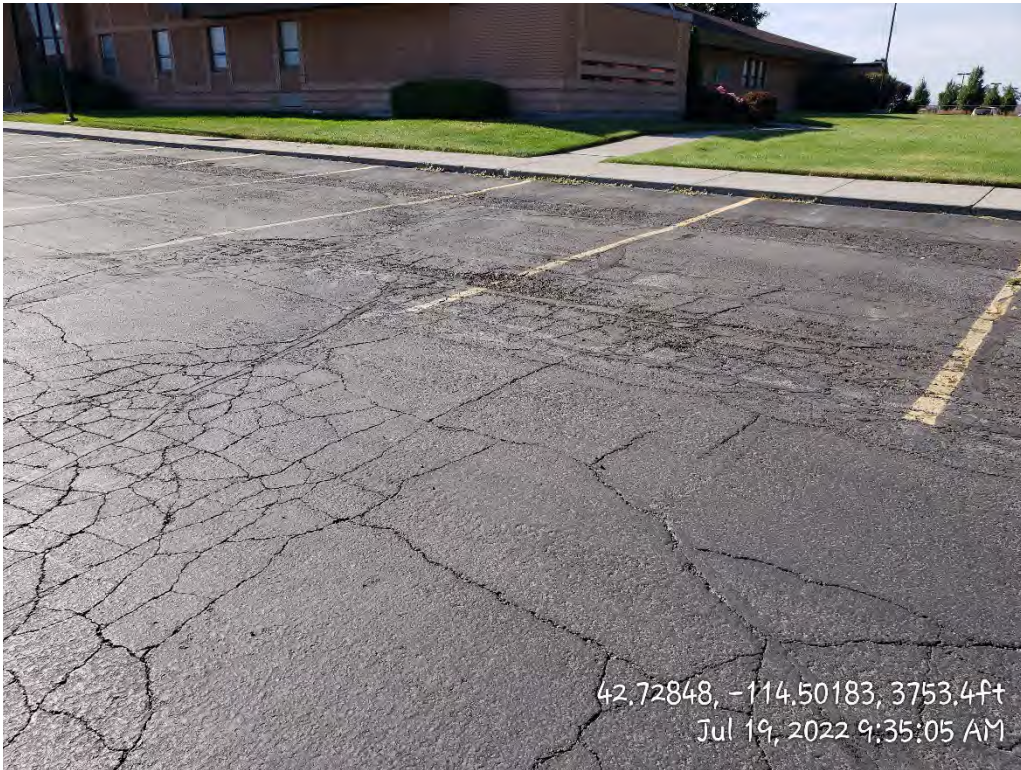
North Lot – Block and Alligator Cracking with Raveling

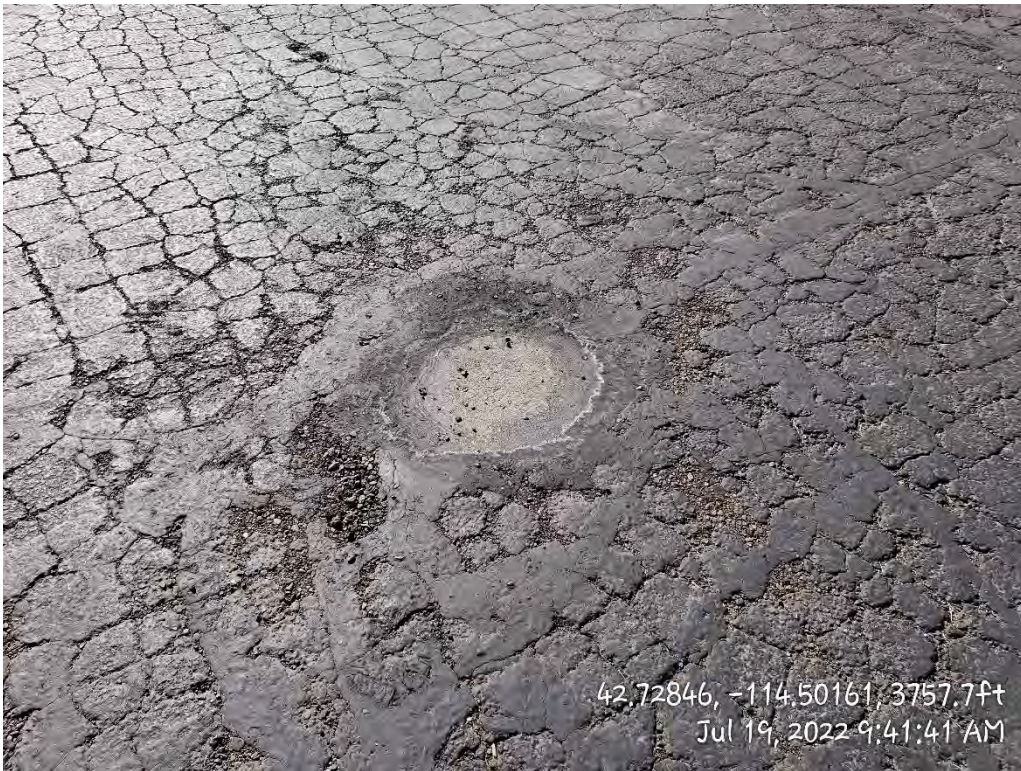
North Lot – Alligator Cracking and Raveling with Pothole

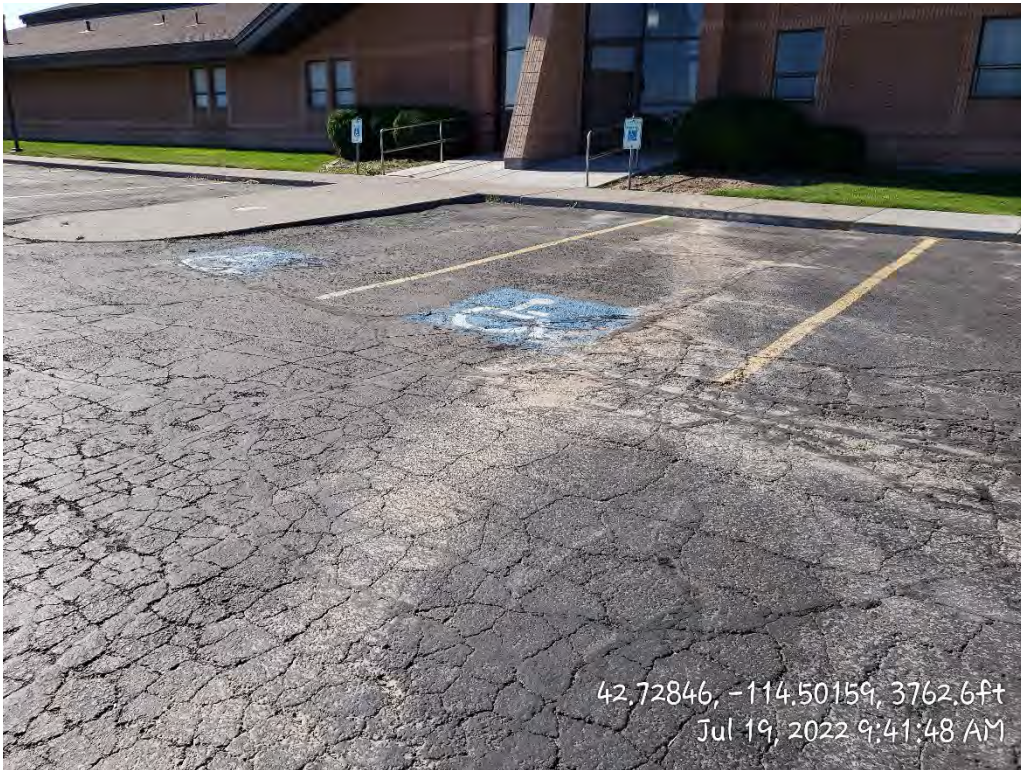
North of Building – Block and Alligator Cracking with Rutting Adjacent to Curb

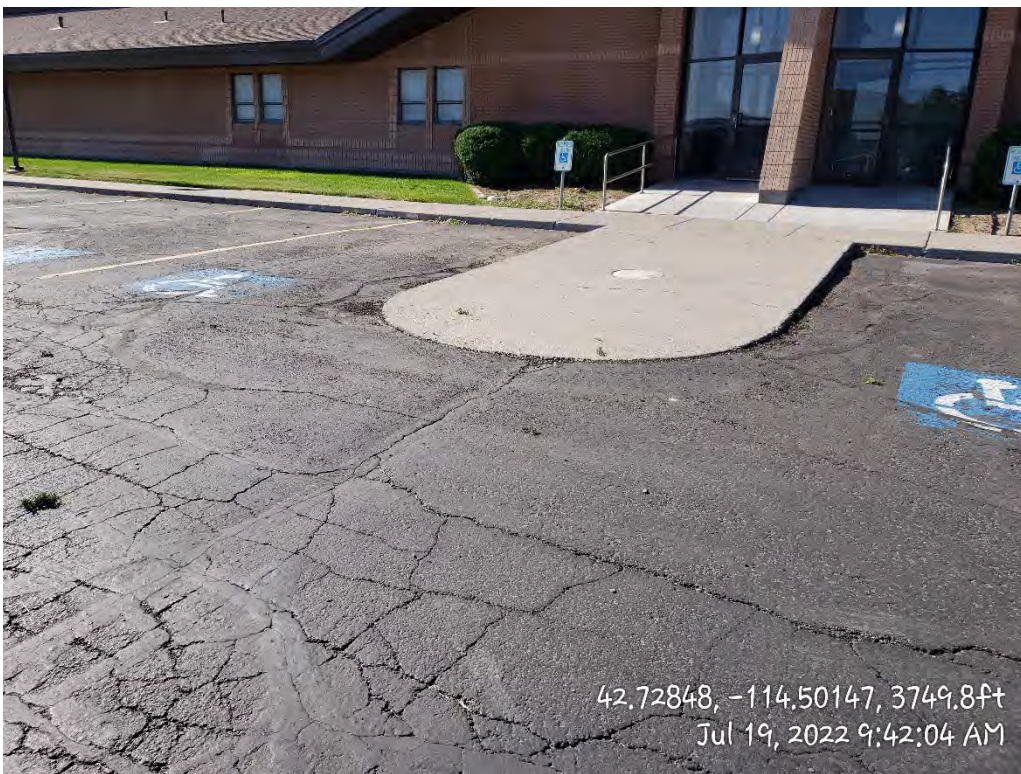
North of Building – Block and Alligator Cracking with Rutting Adjacent to Curb

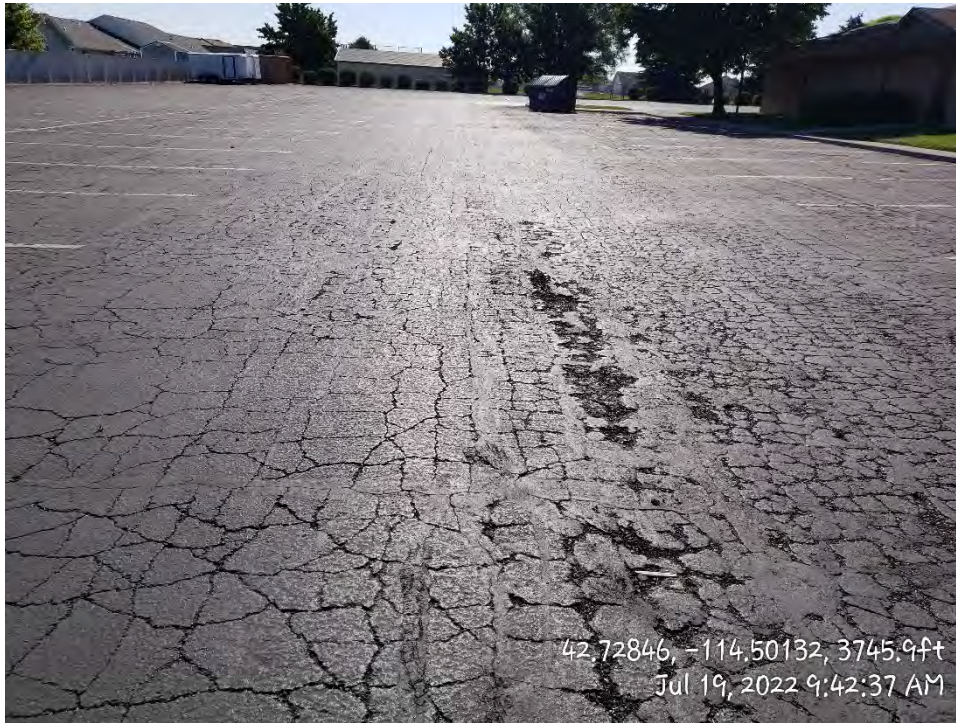
North Lot – Alligator Cracking and Raveling

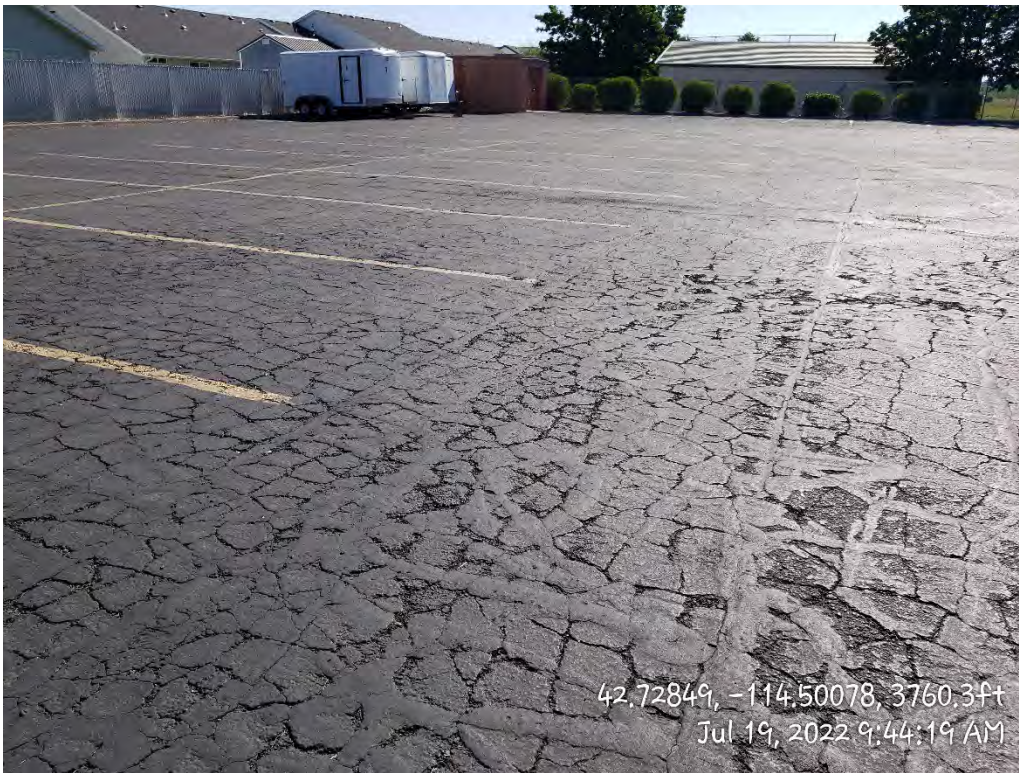
North Lot – Alligator Cracking

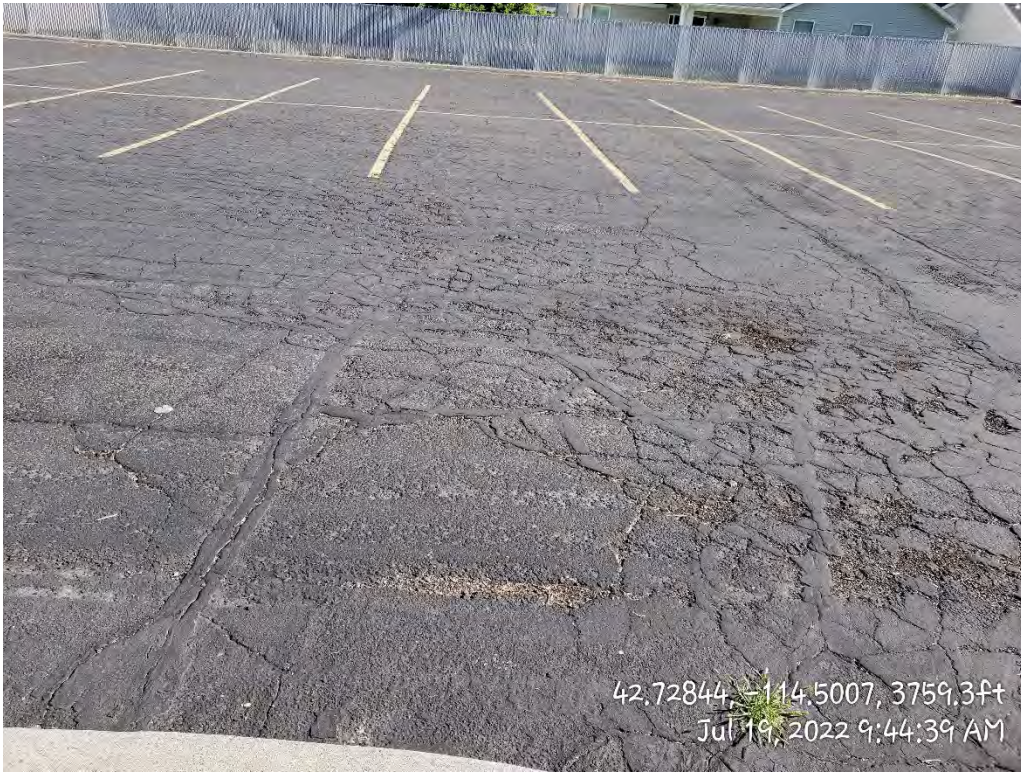
North Lot – Block and Alligator Cracking with Utility Patch

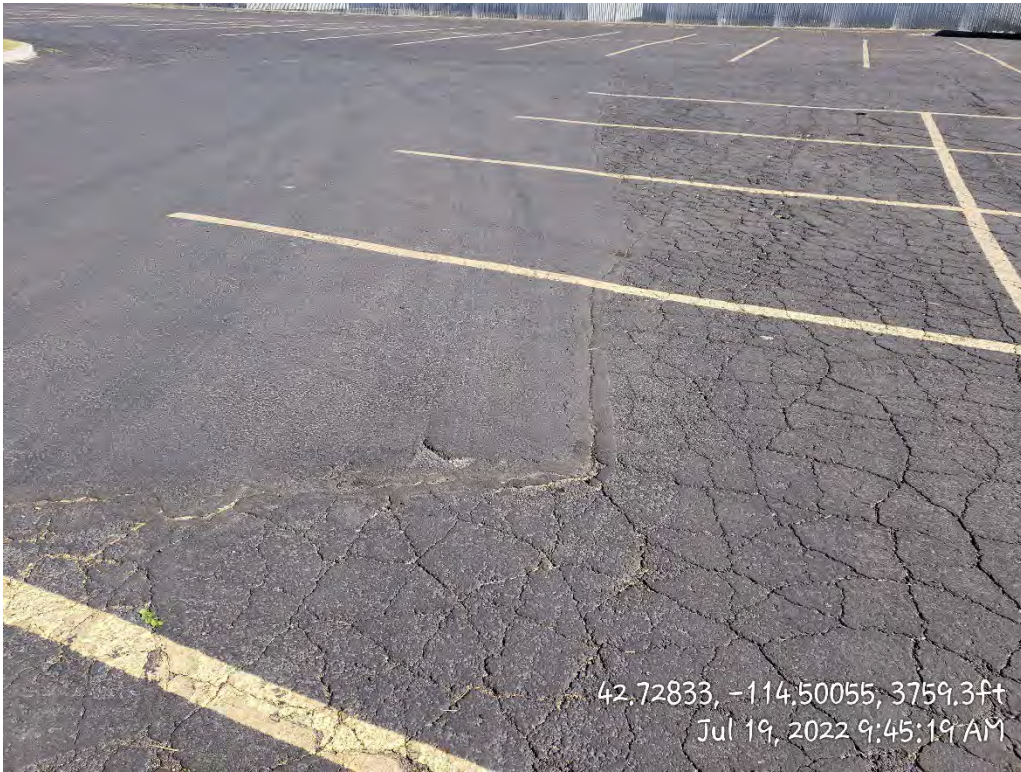
East Lot – Alligator Cracking with Repair Patch

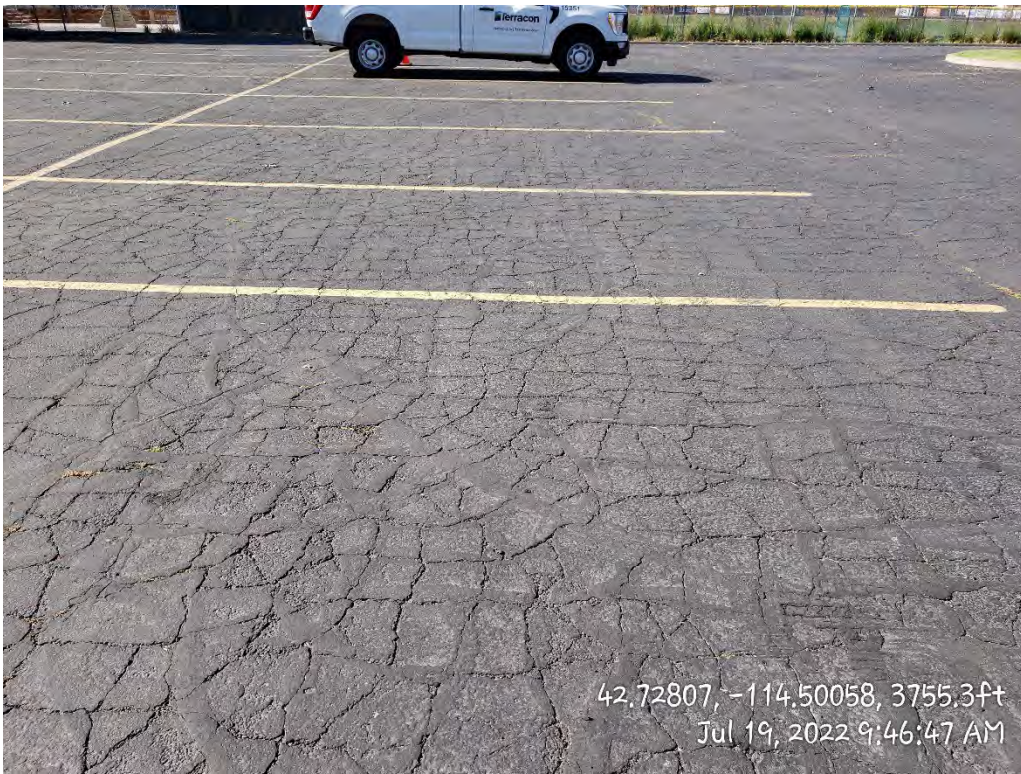
East Lot – Alligator Cracking

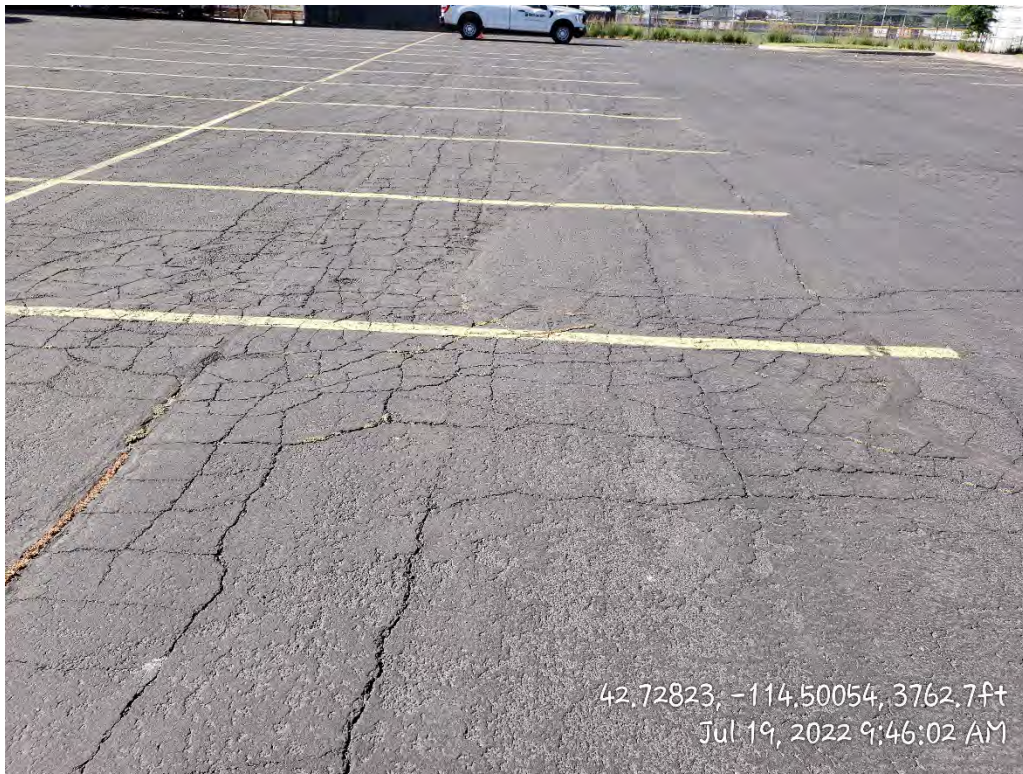
East Lot – Block and Alligator Cracking

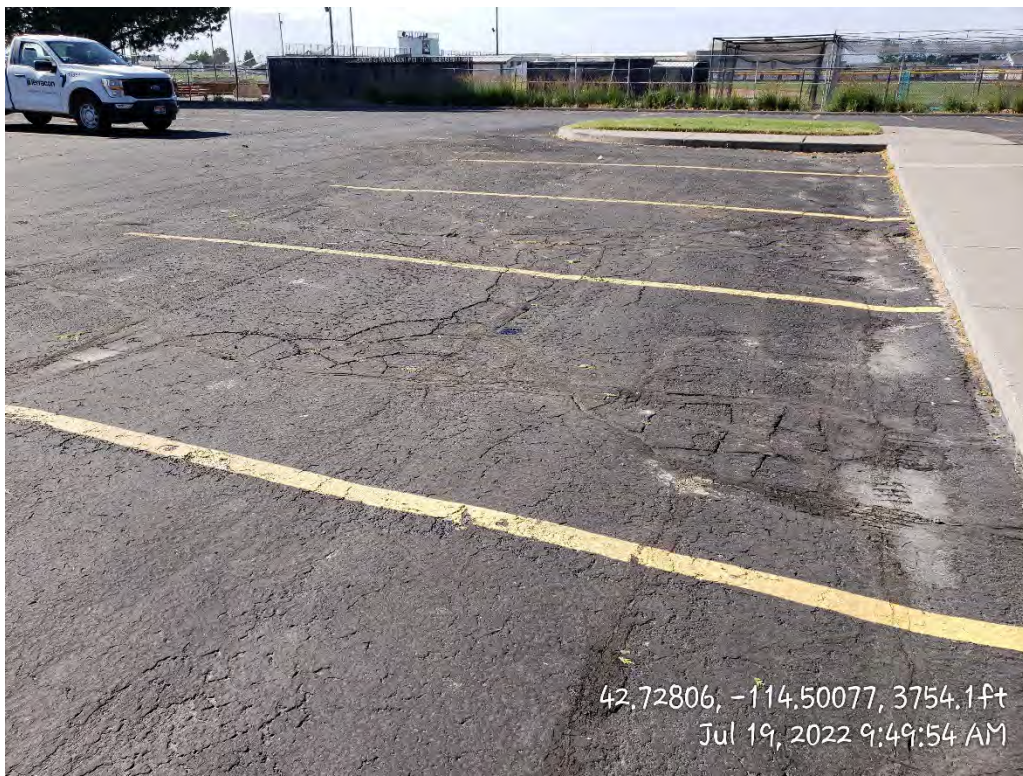
East of Building – Alligator Cracking and Rutting Adjacent to Curbing

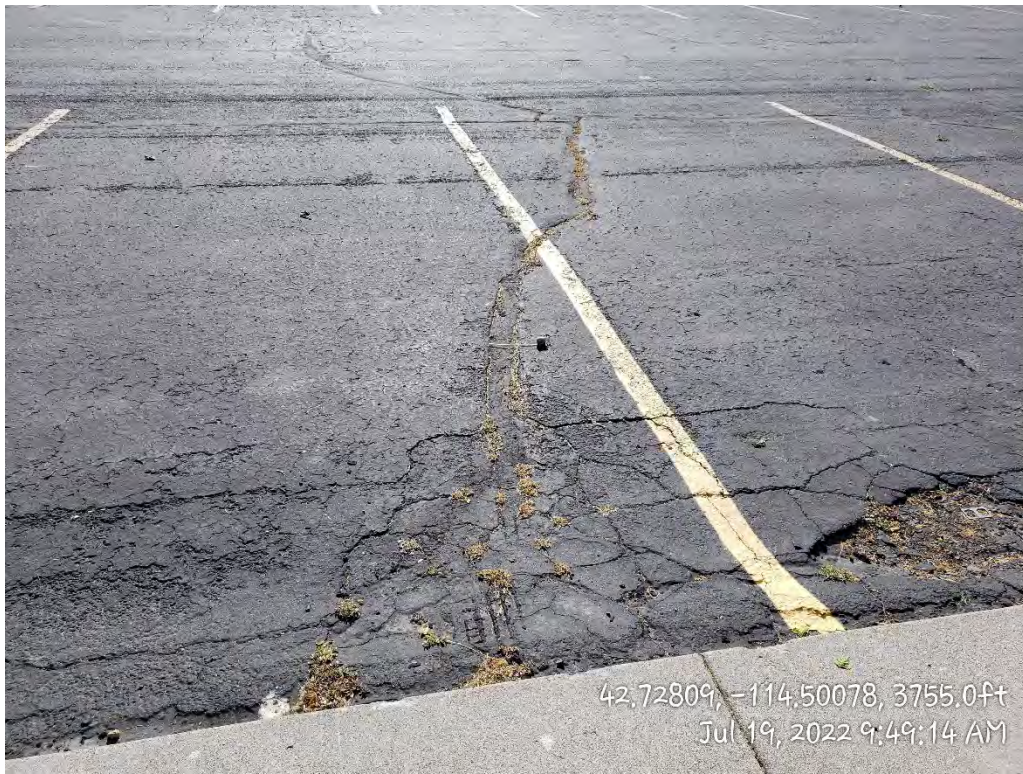
East of Building – Alligator Cracking, Raveling, and Rutting Adjacent to Curbing

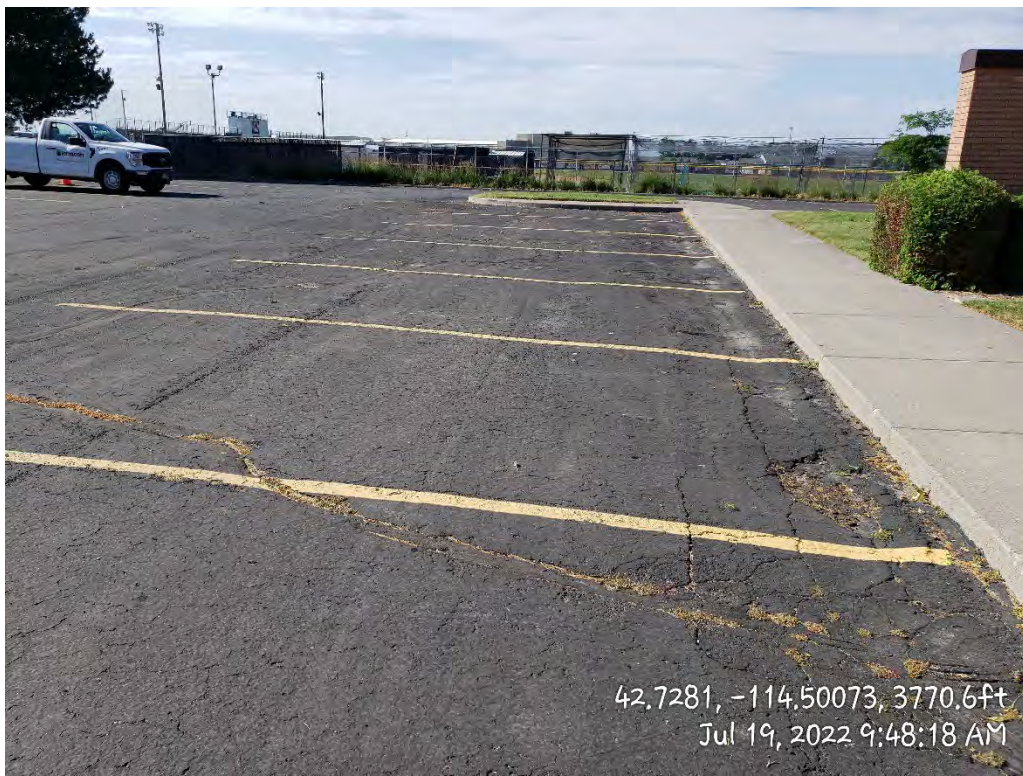
East of Building – Alligator Cracking, Raveling, and Rutting Adjacent to Curbing

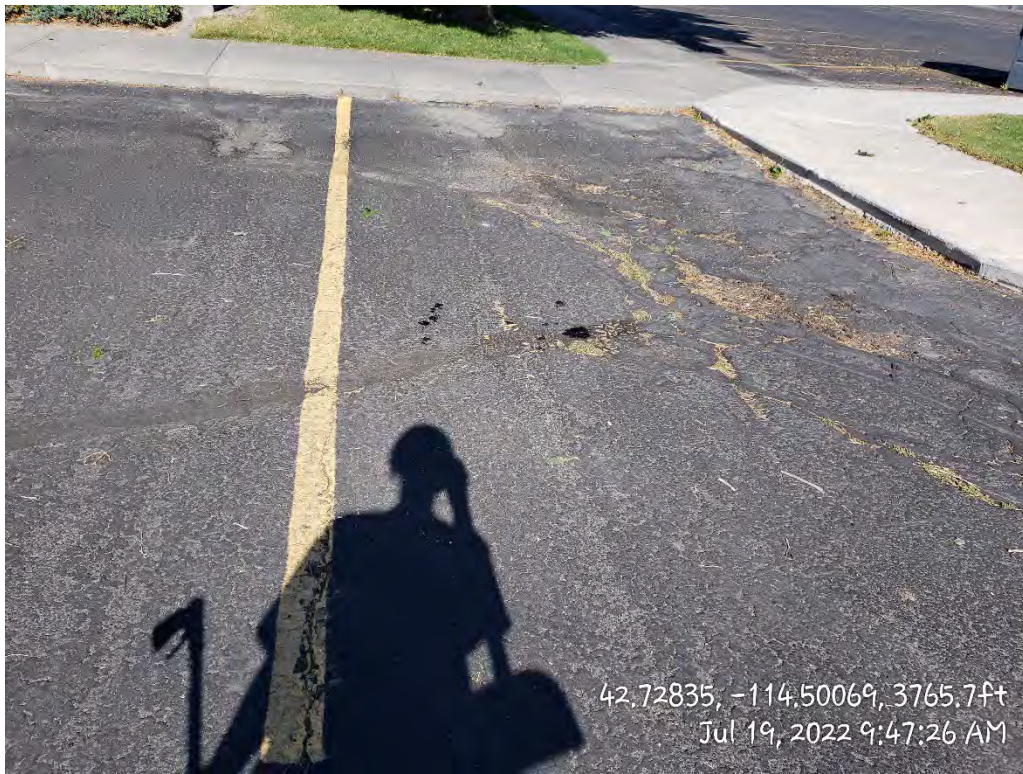
East of Building – Alligator Cracking, Raveling, and Rutting Adjacent to Curbing

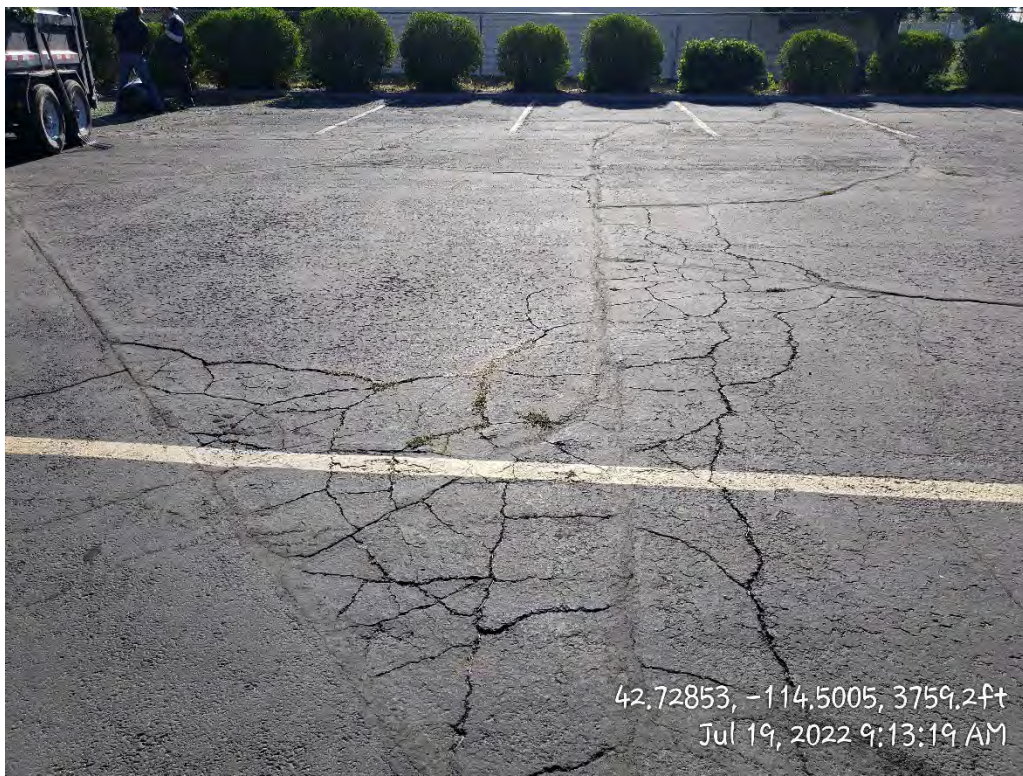
East Lot – Block and Alligator Cracking

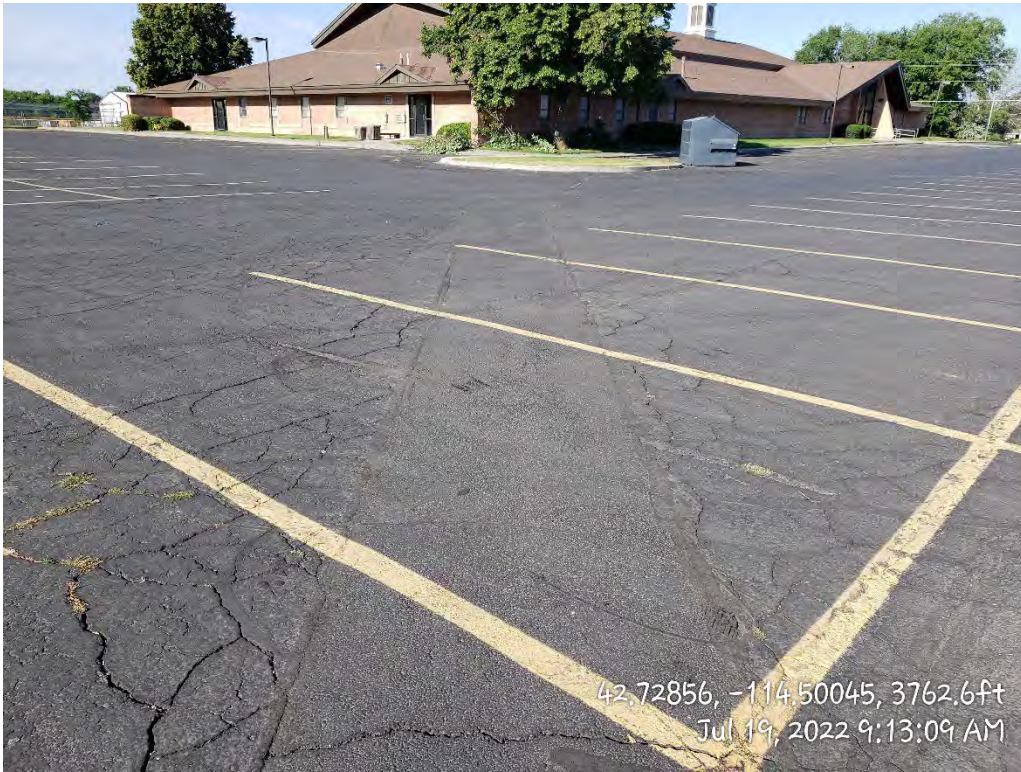
East Lot – Utility Patch with Cracking

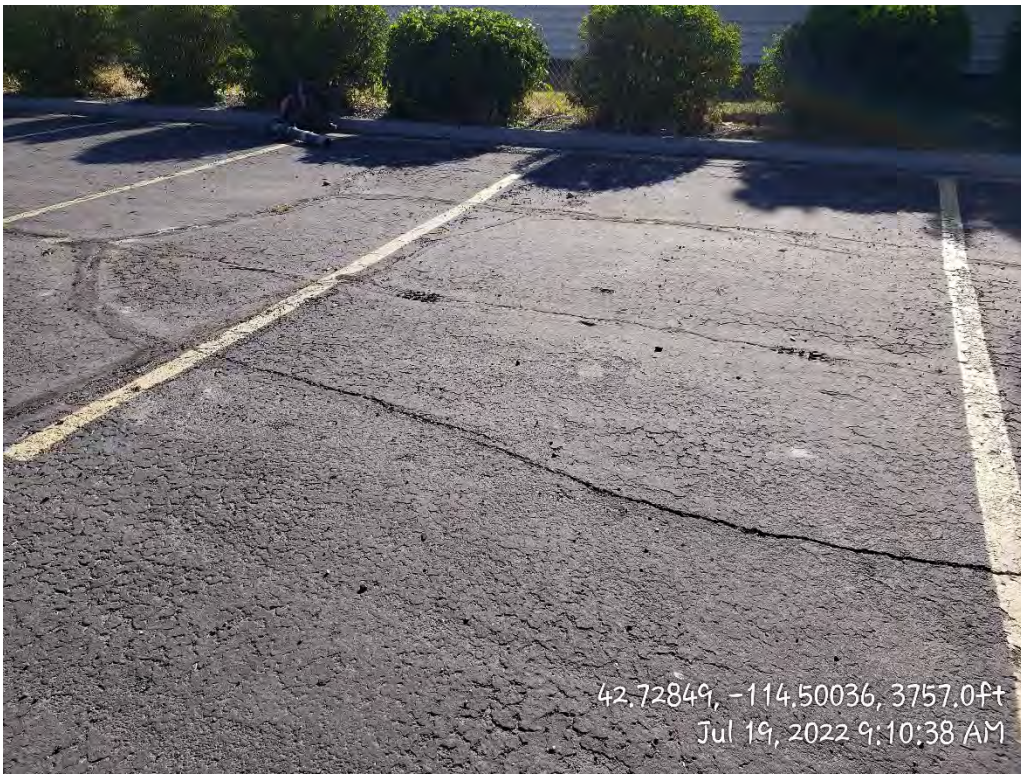
East Lot – Transverse and Longitudinal Cracking with Raveling

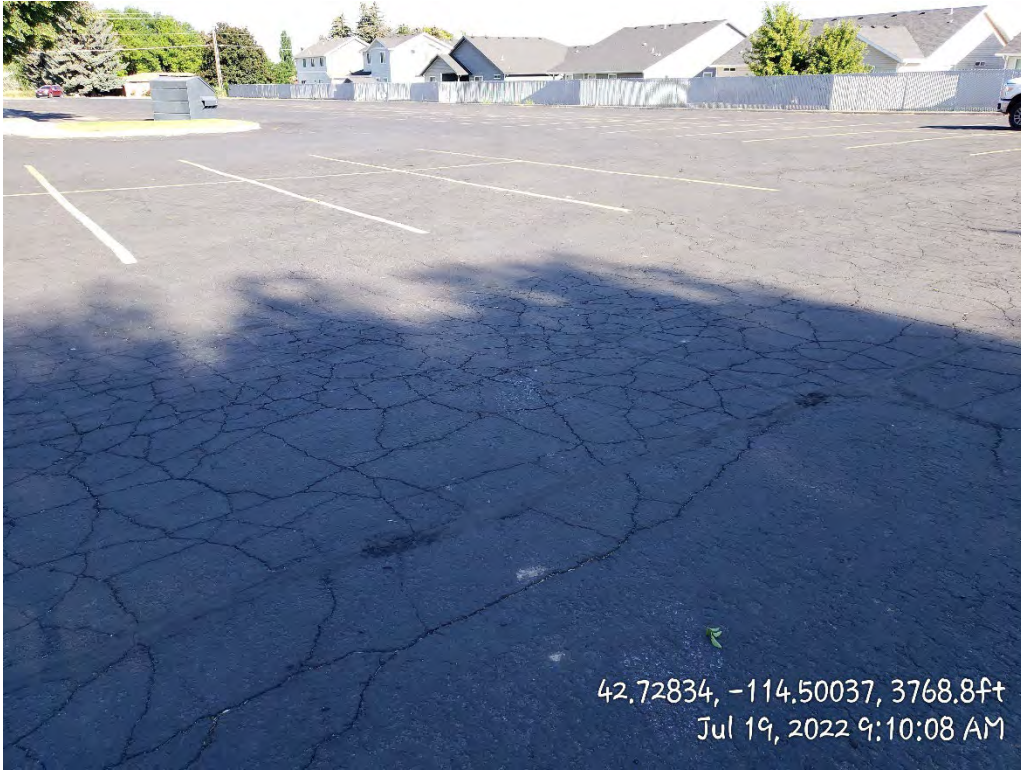
East Lot – Block and Alligator Cracking

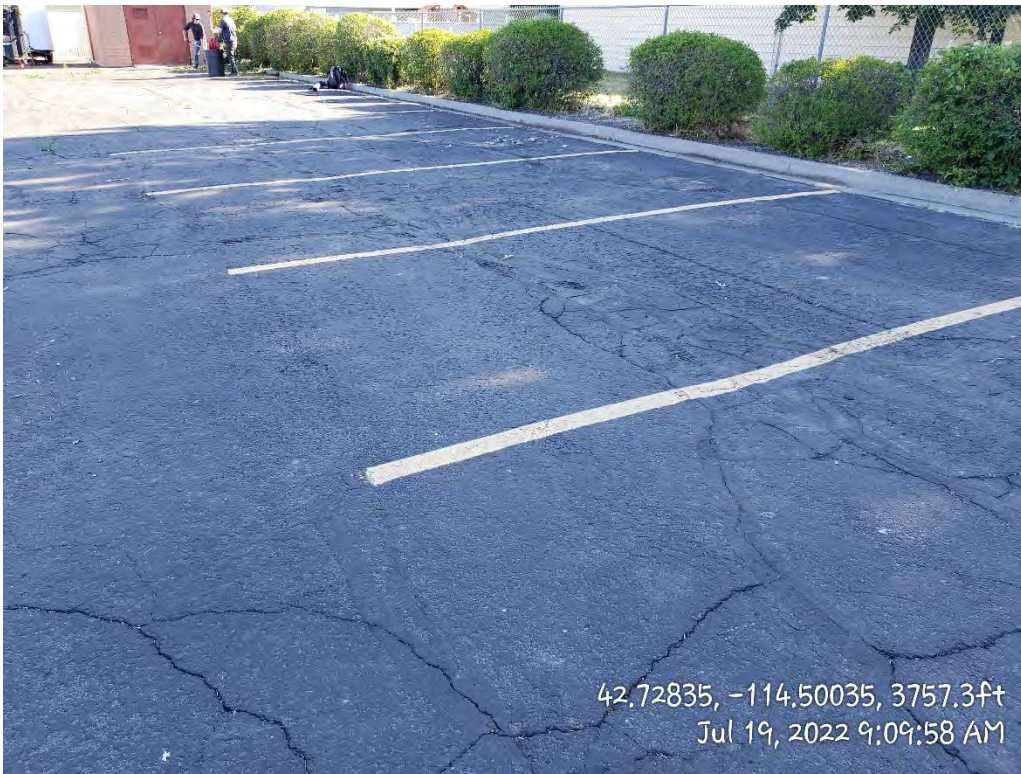
East Lot – Transverse, Longitudinal, and Block Cracking

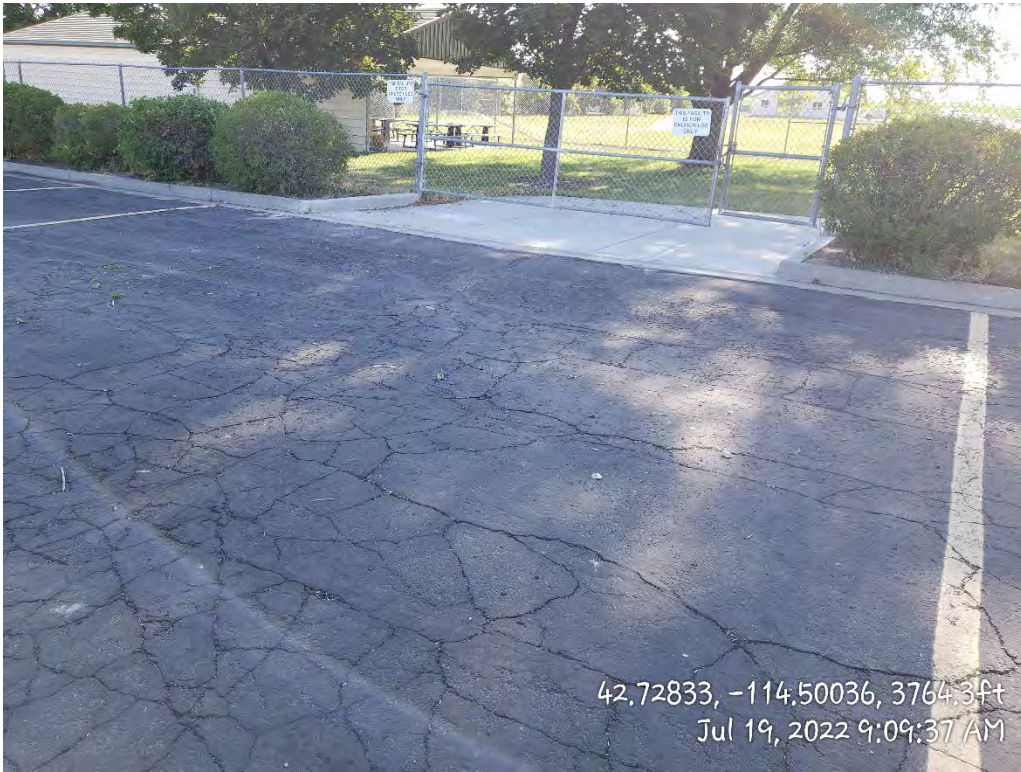
East Lot – Block and Alligator Cracking

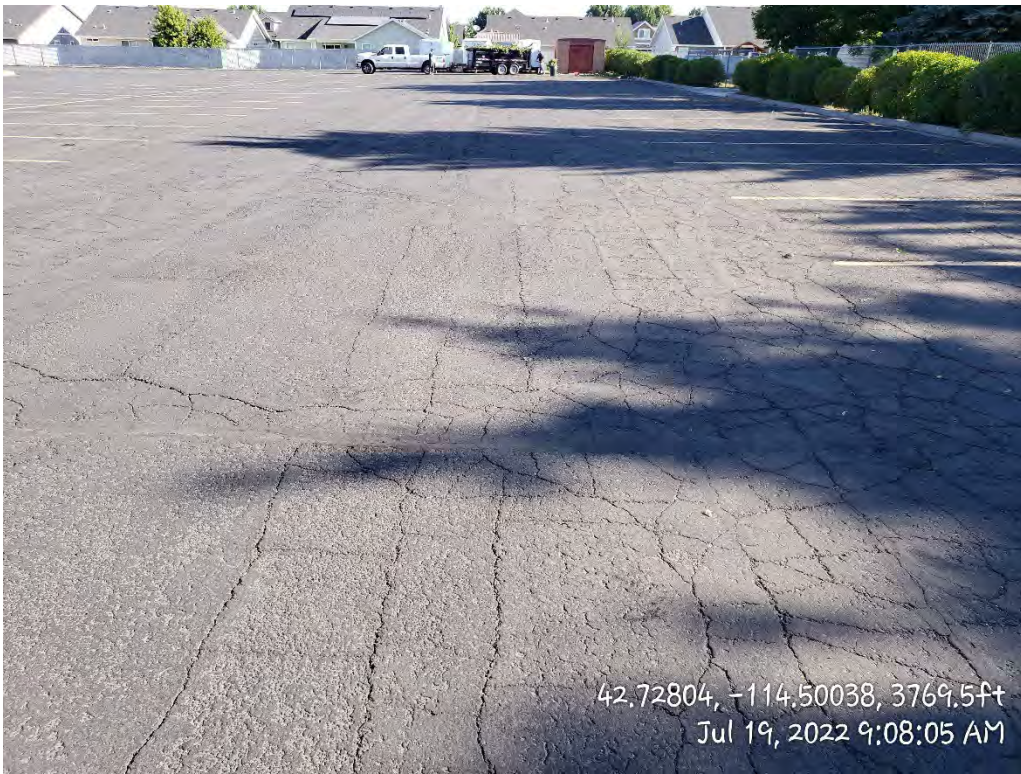
East Lot – Transverse, Longitudinal, Block, and Alligator Cracking

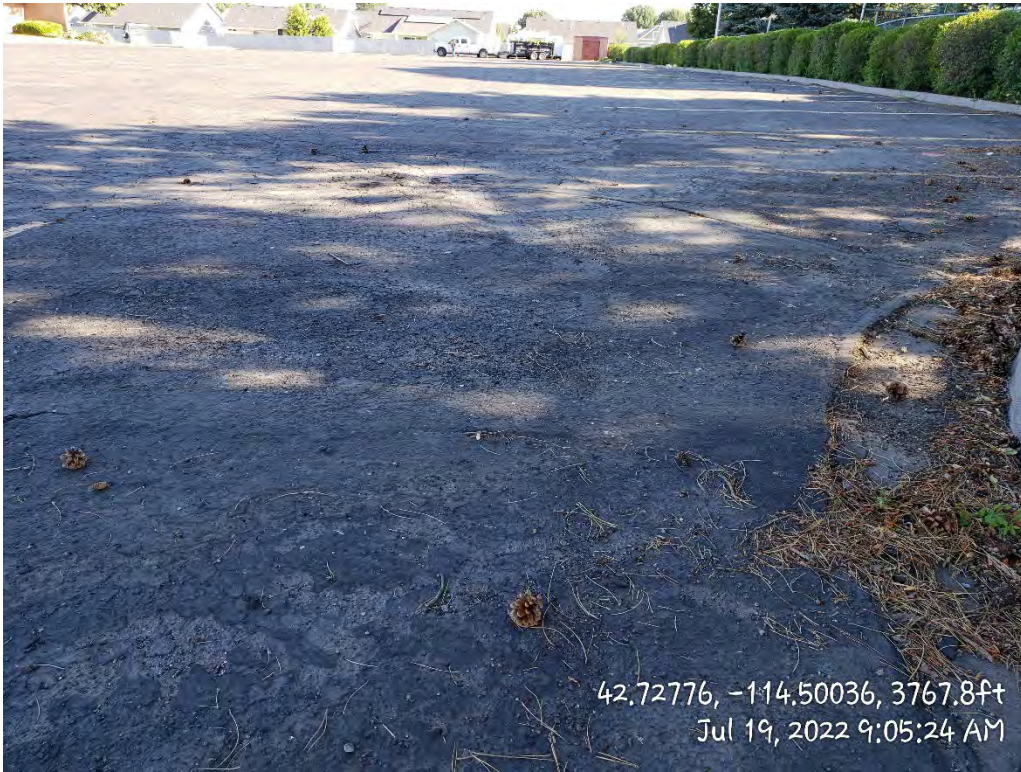
East Lot – Raveling

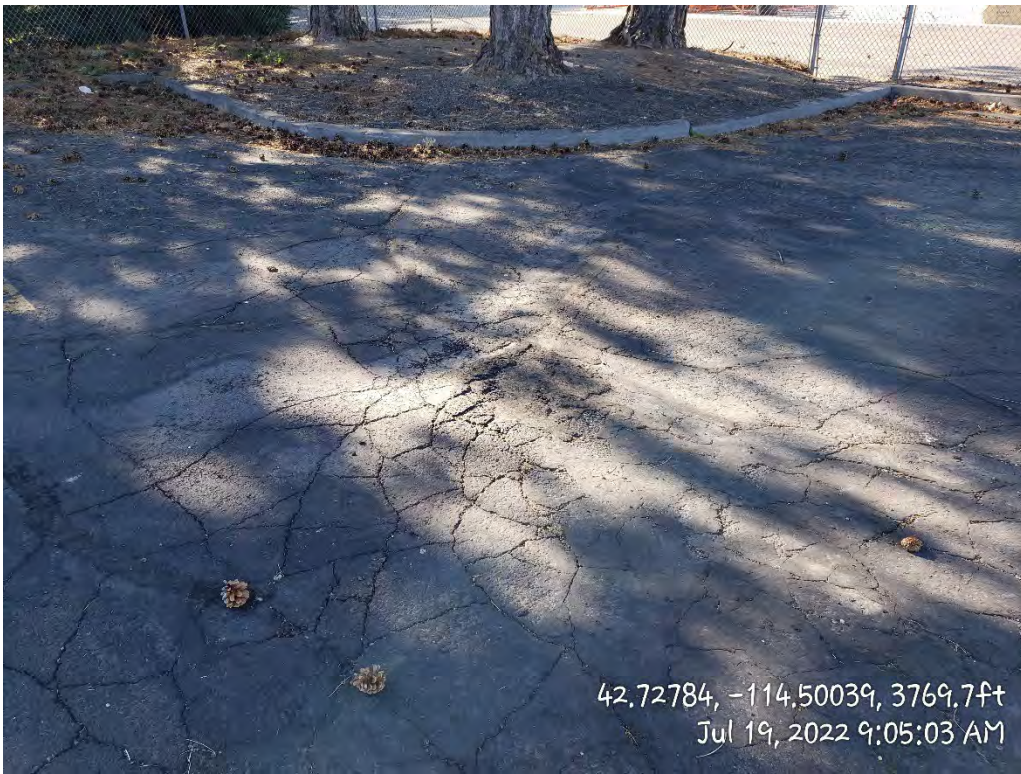
Southeast Corner – Undulating due to Tree Roots

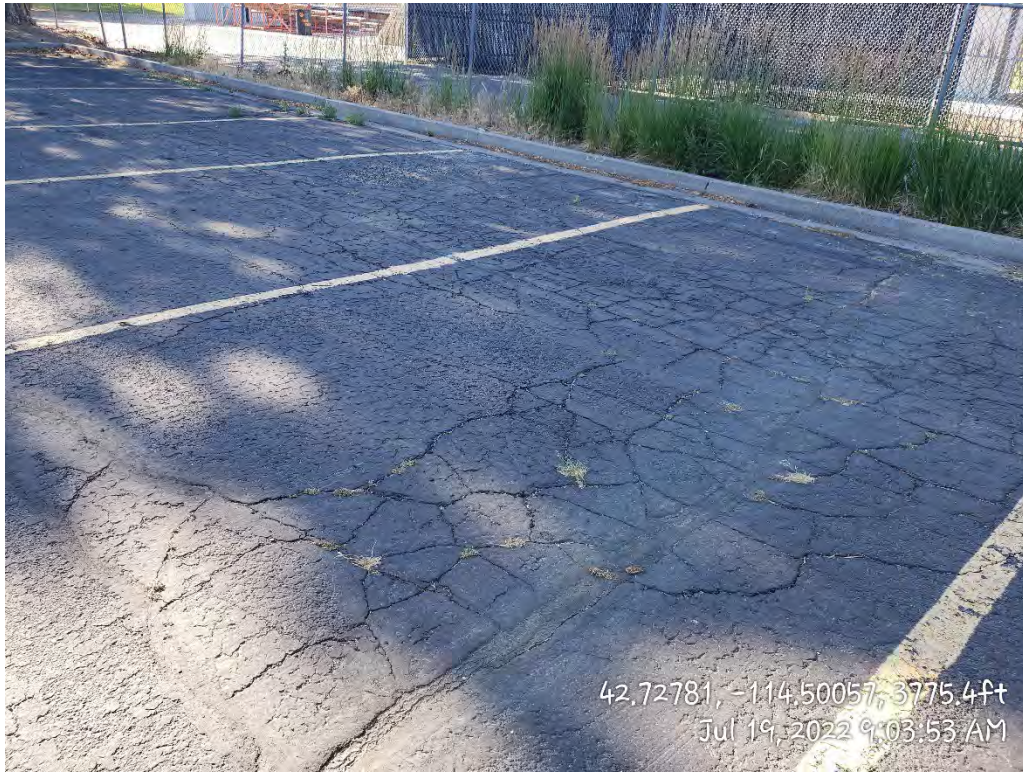
East of Building – Block and Alligator Cracking
