Pavement Evaluation Report

Jerome Stake Center
26 North 100 East, Jerome, Idaho
Property No. 5202701

Re: Pavement Evaluation Report
Jerome Stake Center – Property No. 5202701
26 North 100 East
Jerome, Idaho
Terracon Project No. 62225035

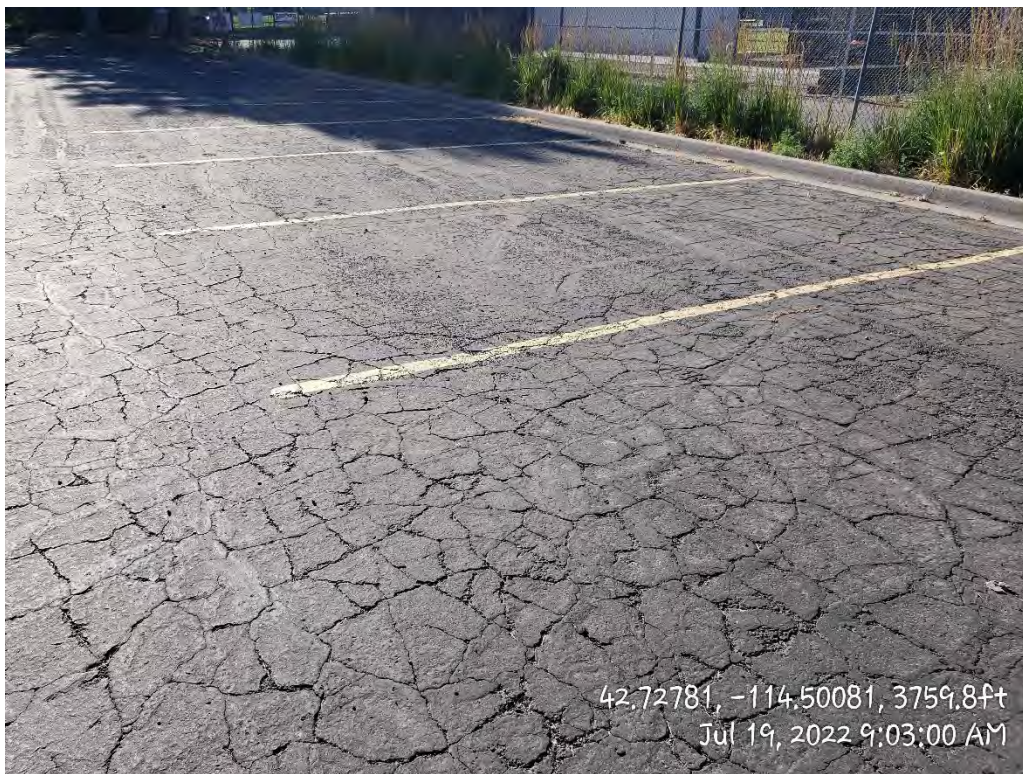
South of Building – Alligator Cracking

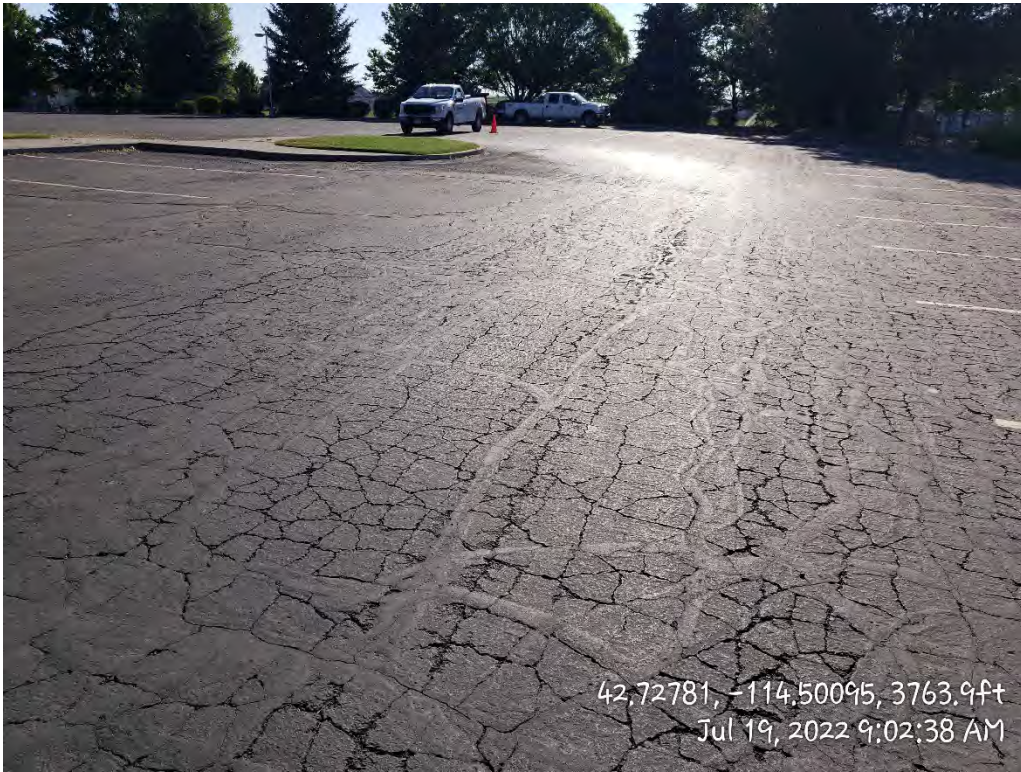
South of Building – Alligator Cracking

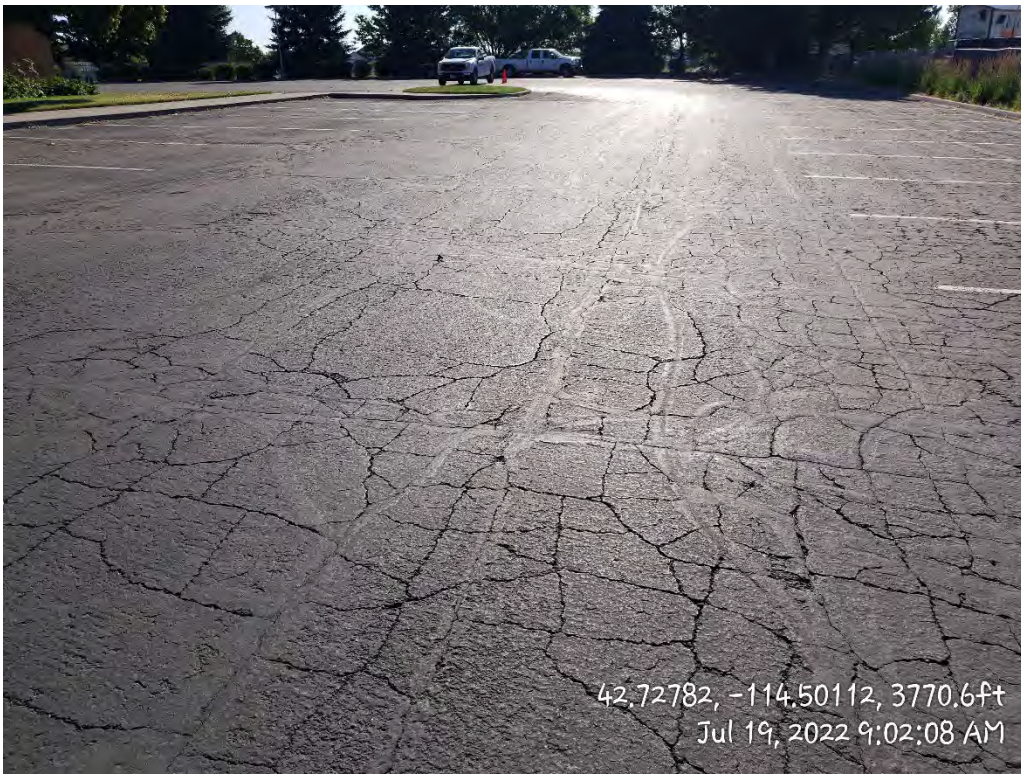
South of Building – Block and Alligator Cracking

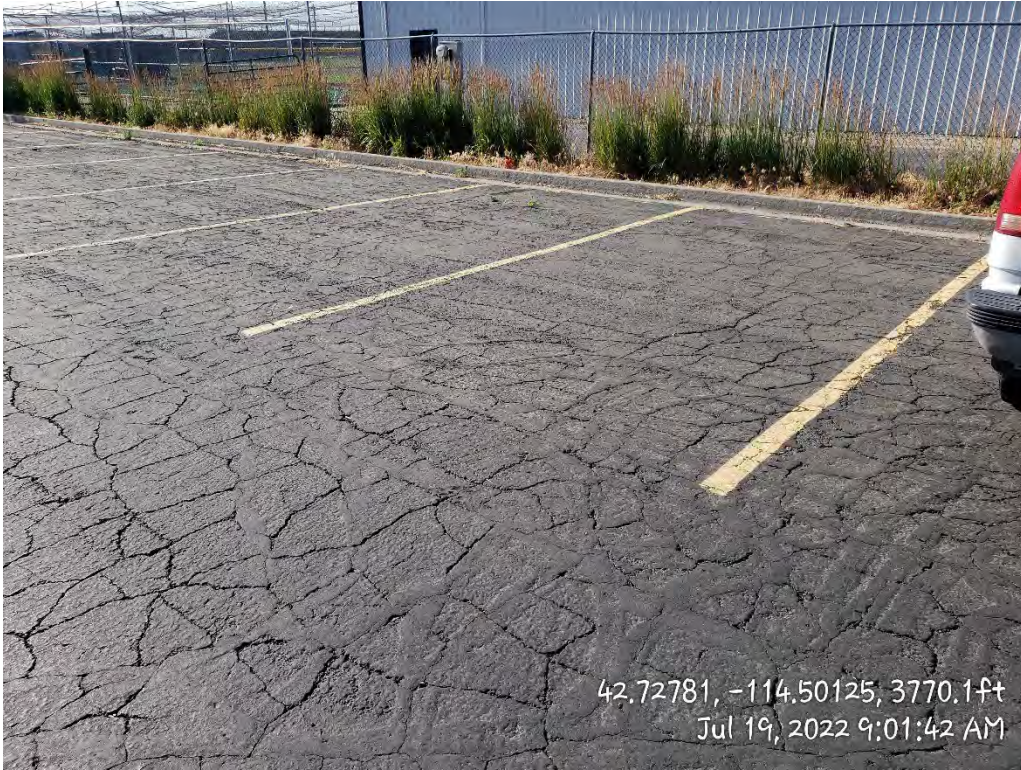
South of Building – Alligator Cracking

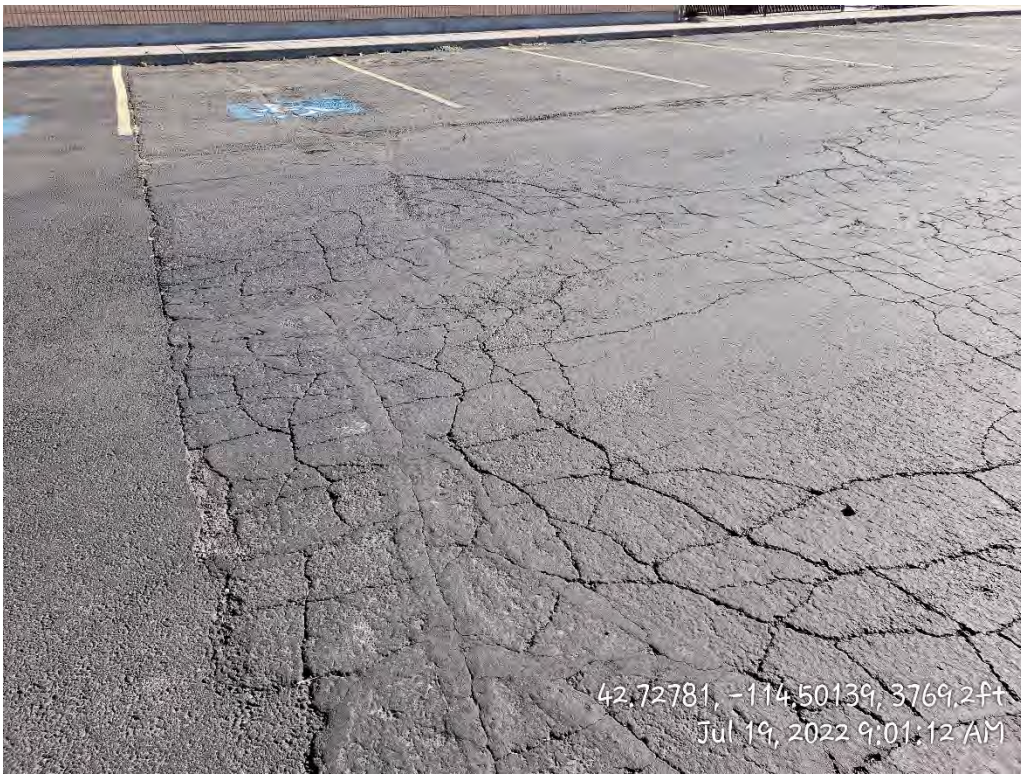
South of Building – Block and Alligator Cracking

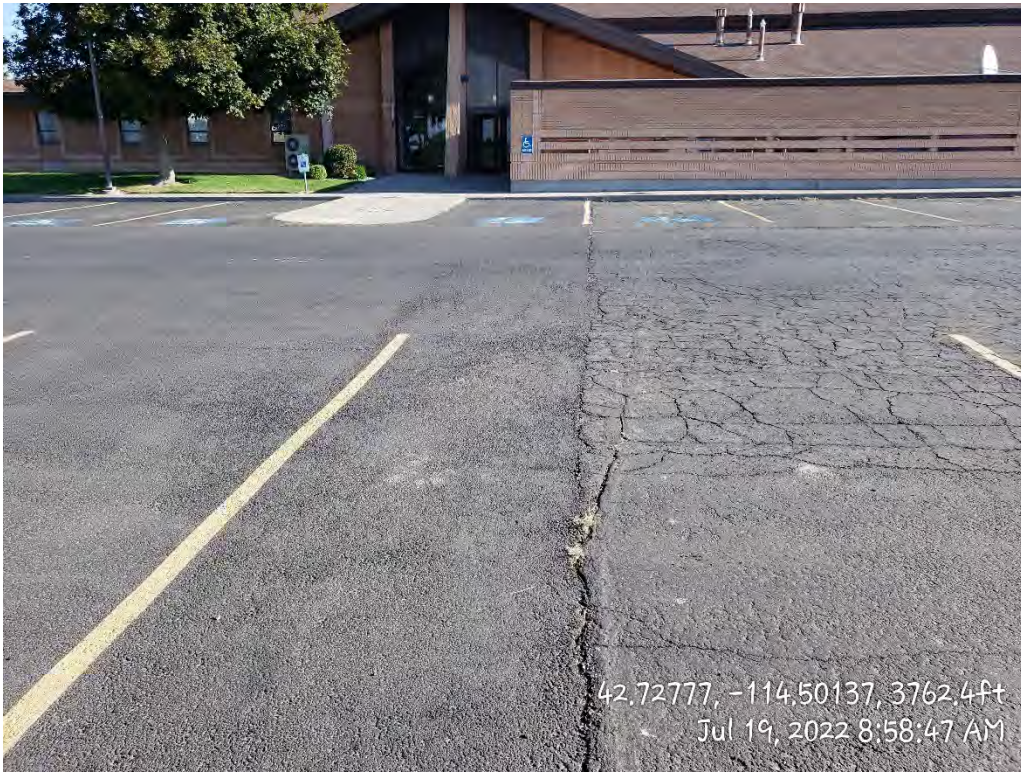
South of Building – Transition from Distressed to Less/Non-Distressed Pavement

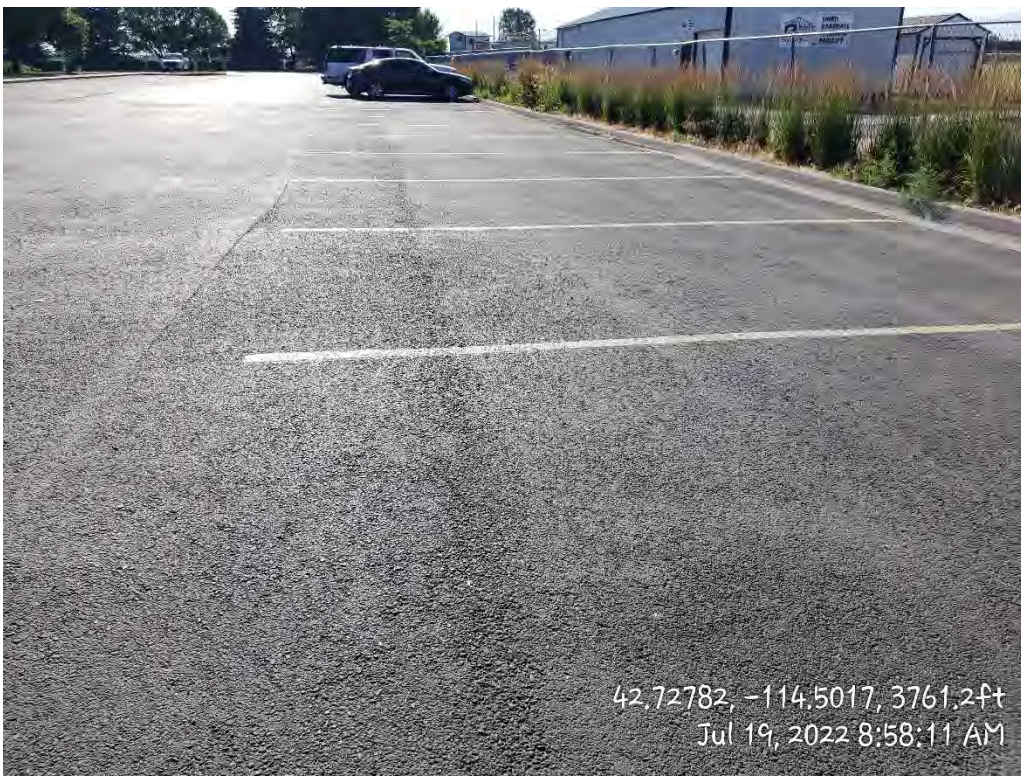
Southwest of Building – Few Visible Distresses
