Pavement Evaluation Report

Jerome Stake Center
26 North 100 East, Jerome, Idaho
Property No. 5202701

Re: Pavement Evaluation Report
Jerome Stake Center – Property No. 5202701
26 North 100 East
Jerome, Idaho
Terracon Project No. 62225035

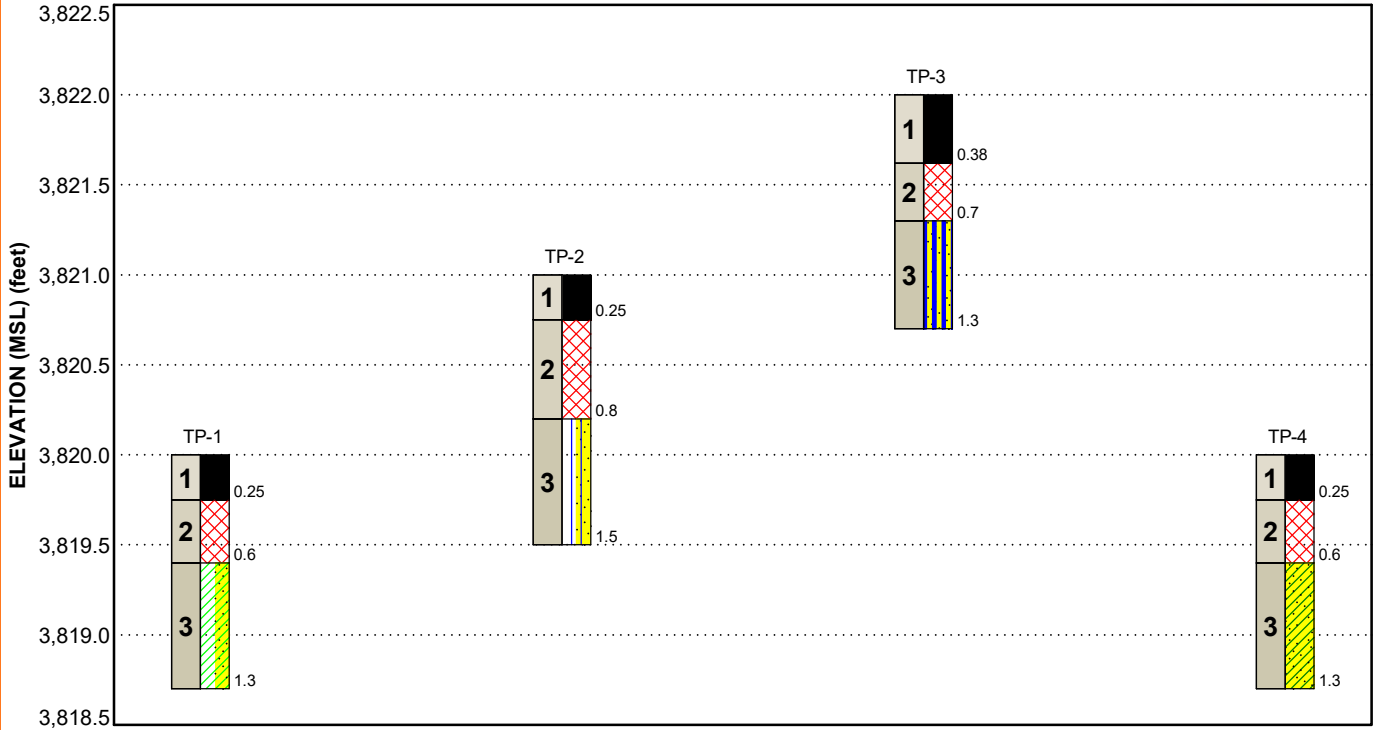
GEOMODEL

Model Layer	Layer Name	General Description
1	Asphalt	Hot mix asphalt.
2	Fill	Fill materials encountered consisted of sand with silt and gravel.
3	Native Silt and Clay	Native soils encountered consisted of silts and clays with varying amounts of sand and varying degrees of cementation.
