# PROJECT MANUAL

# Jefferson Elementary School Addition and Remodel

# *Geotechnical Report*

*For Jefferson Elementary School  
Jerome, Idaho*

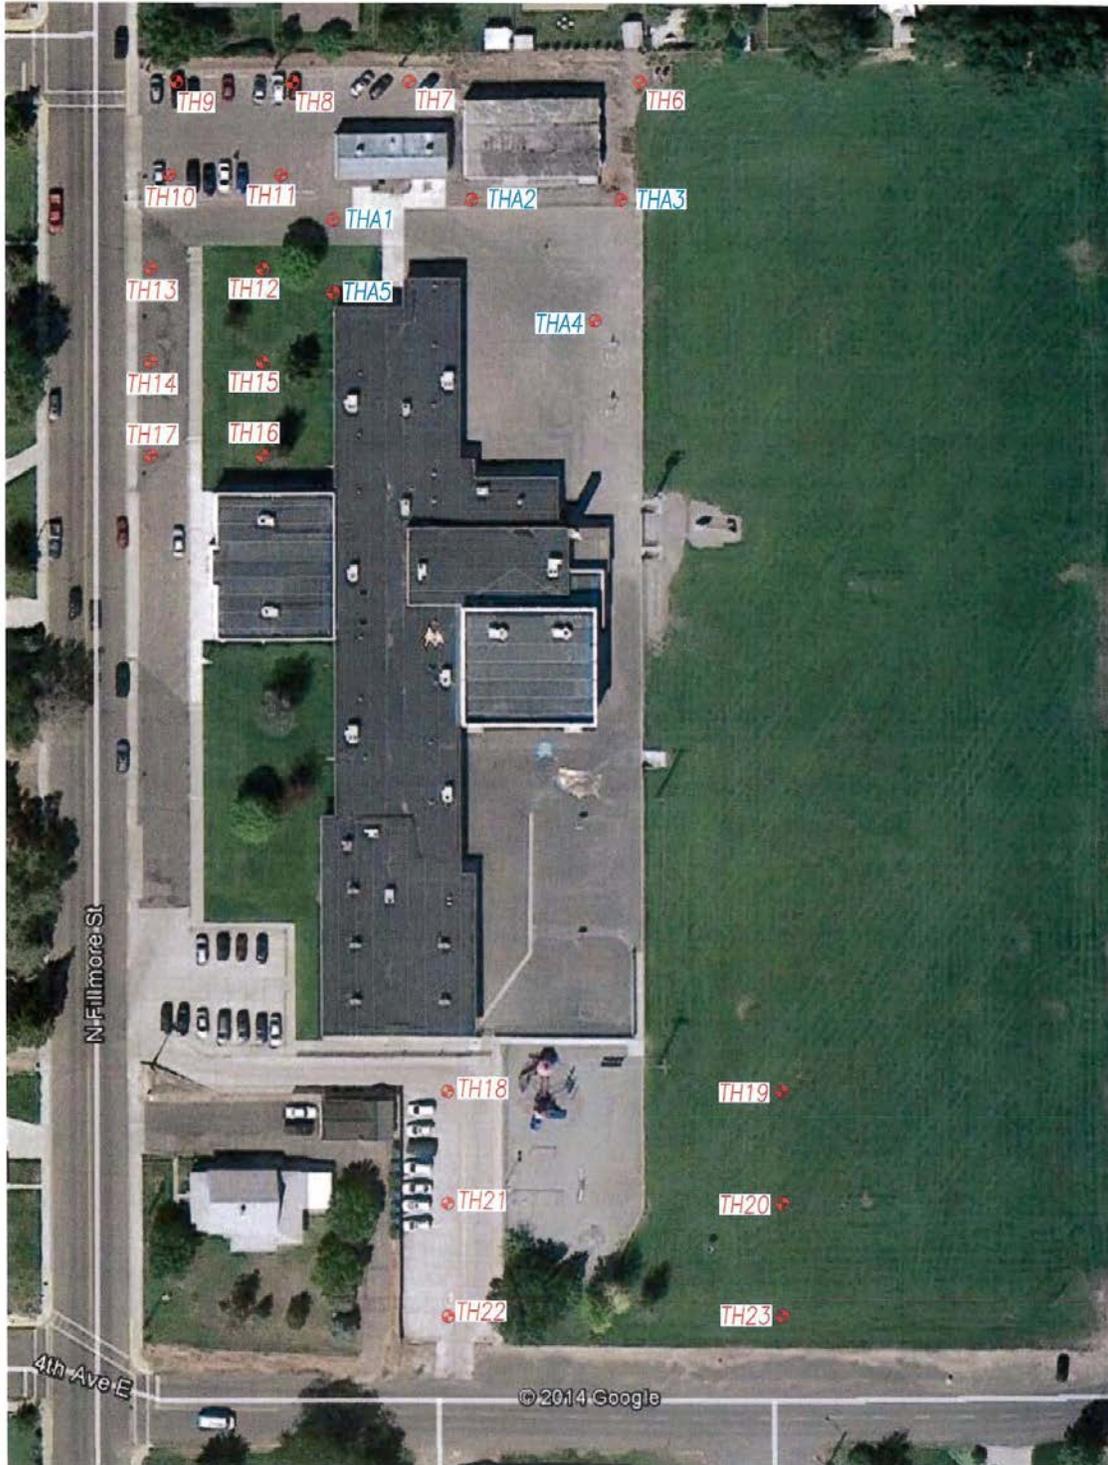
**Figure 2: Test Hole Locations**

Twenty-three (23) holes were located to be drilled in the locations shown in Figure 2. Three (3) of the holes (TH18, TH21, and TH22) were located on a thick concrete slab that would not give to the drill. These three holes were not drilled. Five (5) of the twenty (20) holes were sampled at 2.5'-4' and 5'-6.5' (THA1-THA5). All of these test holes were drilled on April 25, 2014. The approximate locations of the test holes as specified by the architect, LKV Architects of Boise, Idaho, and civil engineer, EHM Engineers, Inc. of Twin Falls, Idaho are shown on Figure 2 and fully described in Table 1.

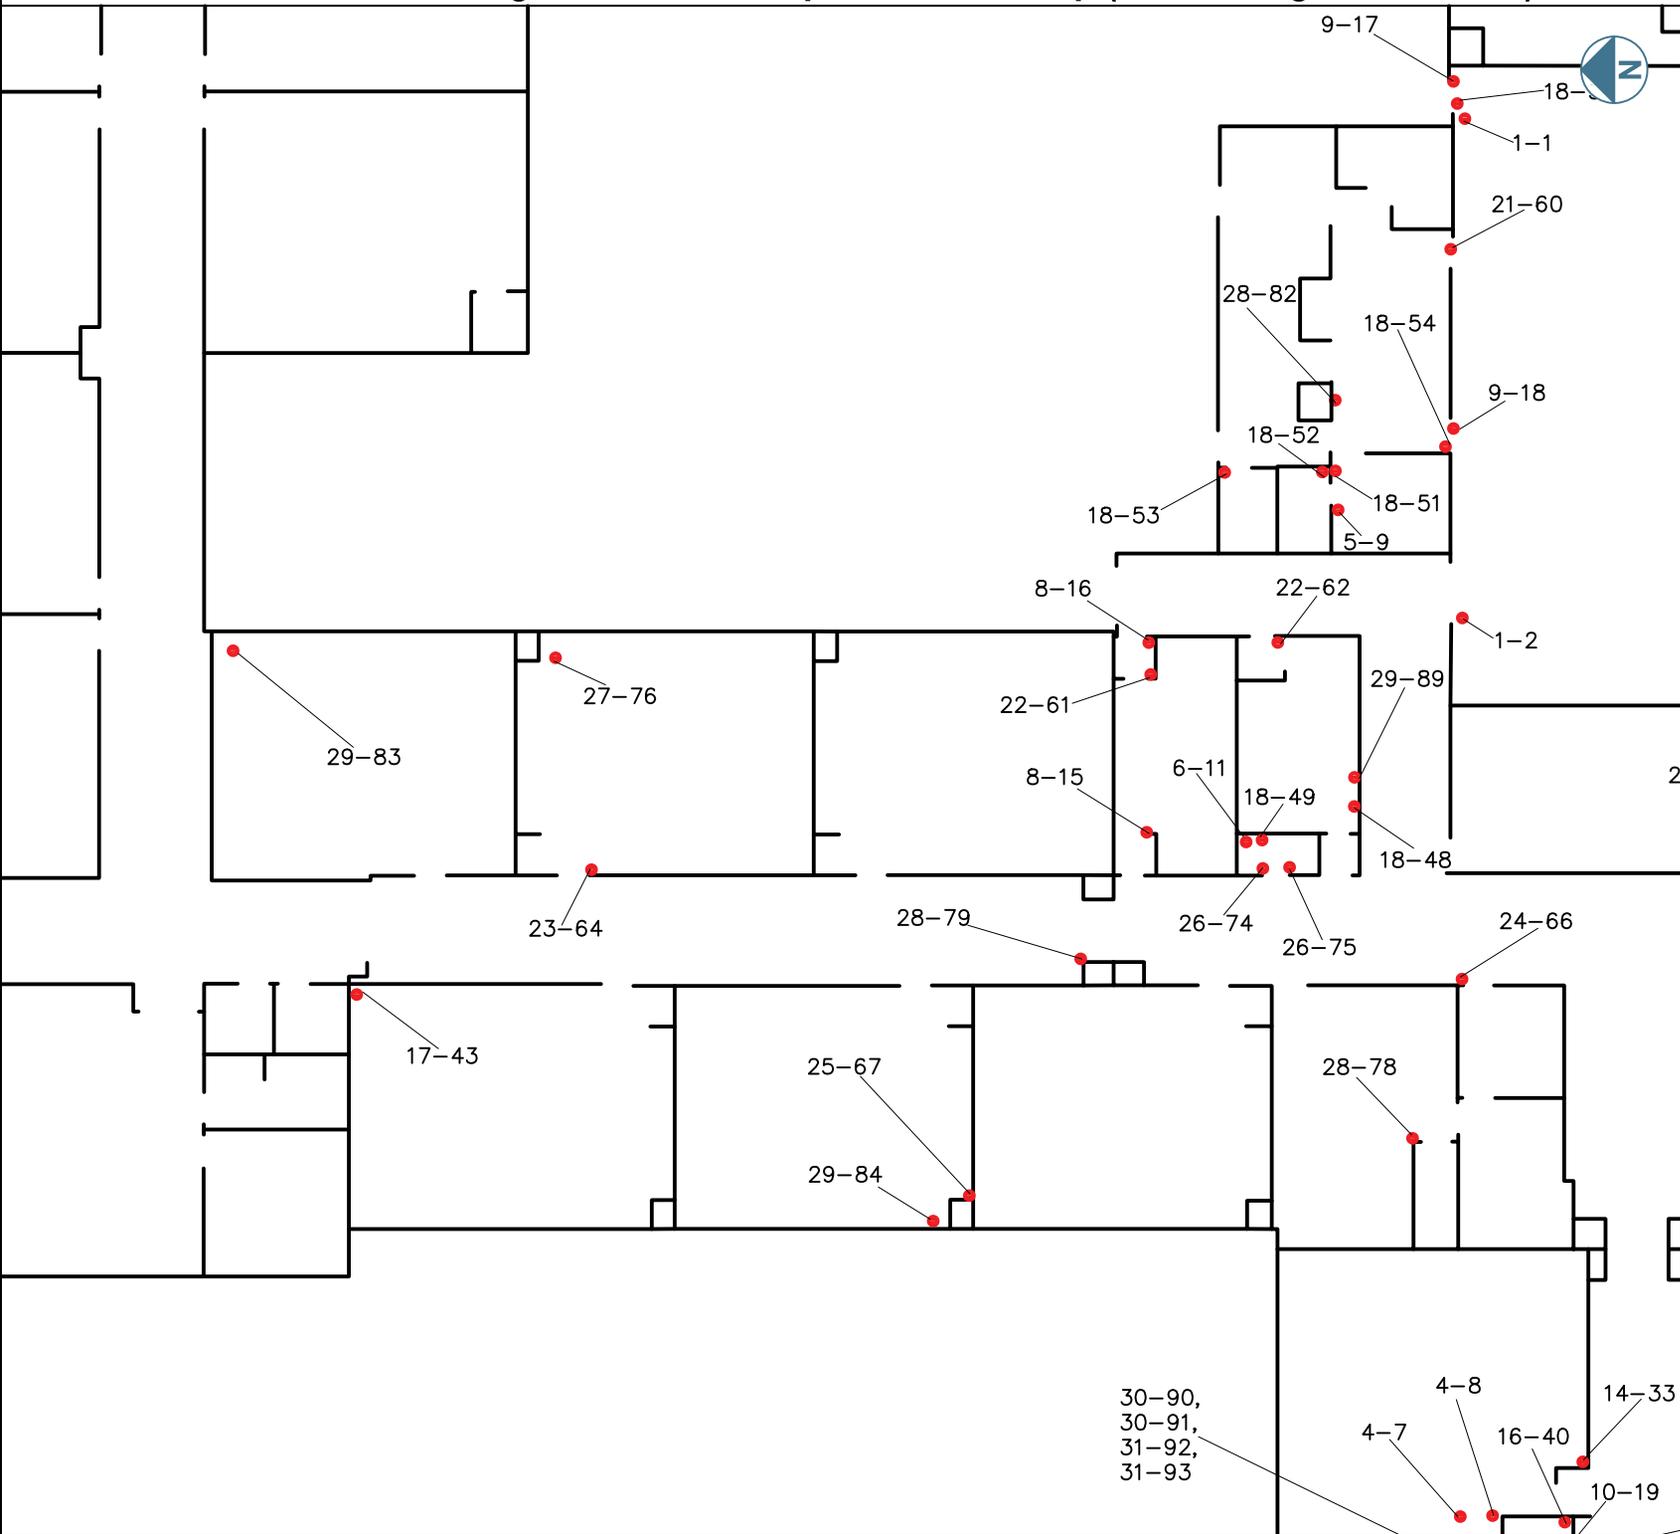
Figure 1a

# Asbestos Containing Materials - Sample Location Map (North Wing and Kitchen)

At the time of the survey, the building was occupied and furnished, and portions of the structure may not have been accessible, specifically wiring. The client reported that the northern addition of the building had been certified to be free of asbestos-containing materials, excluding it from our survey. Plates 1a through 1d depict the location of asbestos samples collected during this survey. Our survey identified the following Asbestos Containing Materials (ACM) to be present, depicted on Plate 2:
